CASE STUDY:

OPONONI SEA WALL

**OPONONI, FAR NORTH, NEW ZEALAND
NOVEMBER 2019**

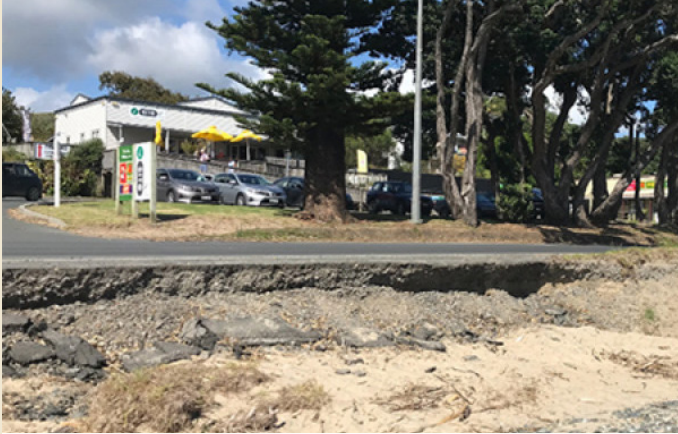
Road erosion before project commencement.

In Opononi located on SH12 the foreshore had suffered recent erosion which was threatening the state highway at multiple locations. SH12 is a key part of the Twin Coast Discovery Route and improving the transport network will make travel for visitors and locals safer, while also enabling future growth and development of the region.

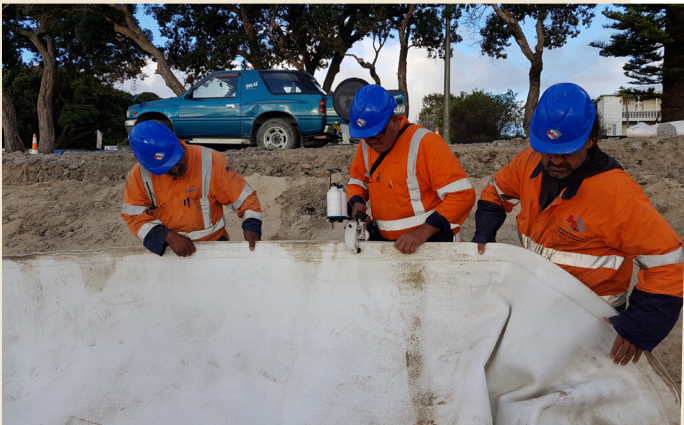
A prayer seam stitch was used to reduce the overlay, using a Class 2200 Union special sewing machine.

During the design stages of the project, Geofabrics supplied technical data on Texcel 1200R along with alternative construction solutions such as sewing which was ultimately used in the project. As per the design and installation guidelines, the Texcel 1200R was installed with both a toe and crest with a fall of 1V:2H. The toe has a two-metre embedment into the sand and crest having a 2.25 metre width. To provide protection to the Texcel 1200R, two layers of armourstone solid rock were used (1100kg as the primary armory with 5 kg-40 kg rocks as the secondary armory) all off which was installed by Northland Transport using rock from the local quarry and installed using excavators. During the installation of the Texcel 1200R, a prayer seam stitch was used to reduce the overlay which was required. The stitch was made using a Class 2200 Union special sewing machine.

The contractor was able to place the Sewn Seam across the face (right angles to the slope) rather than down the face (in the direction to the slope) as required when overlapping. This greatly assisted in the methodology of construction on site in difficult running sand and underwater site conditions. The seam is turned down so that the exposed face is smooth, to avoid collecting debris or affected by hydraulic pressures of wave running up or down the slope. With the use of a sewing seam, it also reduced the overlap required from 300 mm down to 100 mm. This in turn was able to save the contractor both time and material which resulted in a cost reduction to the end client.

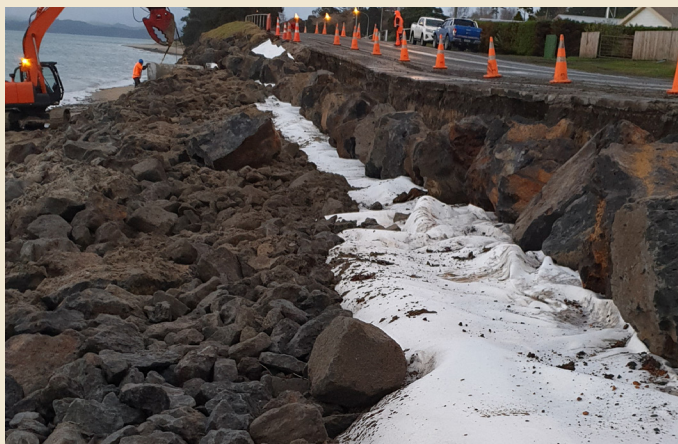
During installation.

To dissipate the energy, as opposed to reflecting the waves to cause problems elsewhere, resulted in the solution of a sloped revetment wall. The wall would have a filter layer to retain the sand backslope material, a carefully sized protective underlay with durable specifically selected size, shape and weight graded Armourstone. These factors, the shape, the structures elevation, slope, site exposure, toe founding conditions, a scour apron and a crest bench were all carefully considered and critical to the project success in keeping the road open.
